WORK TO START AGAIN ON THE TREES IN NORTHWOOD PARK

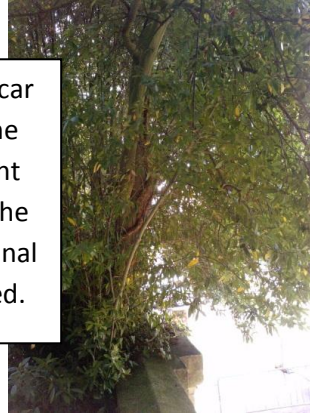
T1202 (bay tree)

This tree overhangs the Rotunda car park. It is self-sown and forms one of the group of trees whose weight is causing damage to the wall of the car park. It is not part of the original Park tree plan and will be removed.

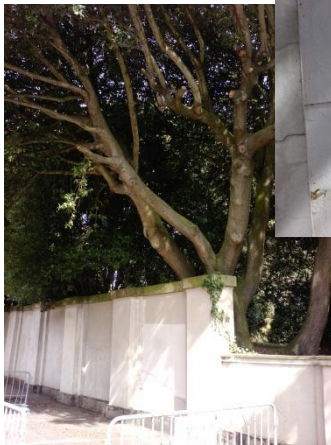
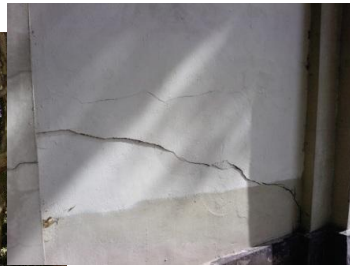
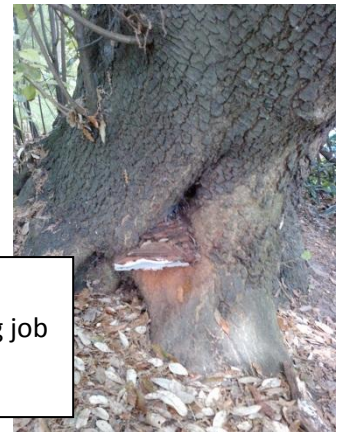
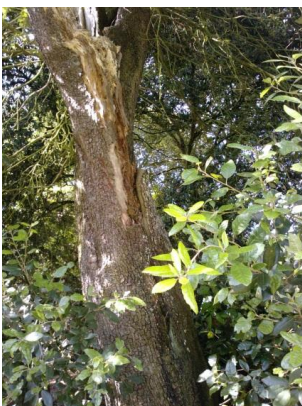
T1203 (holm oak)

This tree is causing more concern than any other in the Park at present. As you can see, it is leaning heavily on the wall of the Rotunda car park and the weight of its trunk – holm oaks have very dense, heavy wood – and its

overgrown foliage have combined to cause very significant cracking and movement in the wall. The parking spaces immediately under the tree have been cordoned off in case the wall collapses.

The main trunk of the tree is also suffering from a fungus which is an indicator of decaying wood. Removal of this tree will be a demanding job for the tree surgeon but it is a top priority for the Trustees.

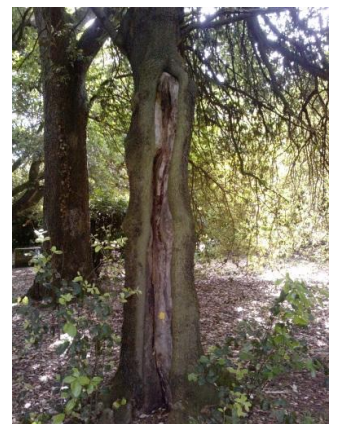
T1211 & T1240 (holm oaks)

These are two more of the many – often self-sown – holm oaks present in the Park. Holm oaks are big, significant trees and can be attractive, but if left unpruned they can develop heavy trunks and the dense, dark canopy of leaves discourages any other growth underneath. The leaves take a very long time to rot down and can be toxic in large quantities. These particular specimens have developed splits where rot has

set in; they have little life left in them and will be felled, partly because they will eventually fall and partly to give space and light to the surrounding healthy specimens.

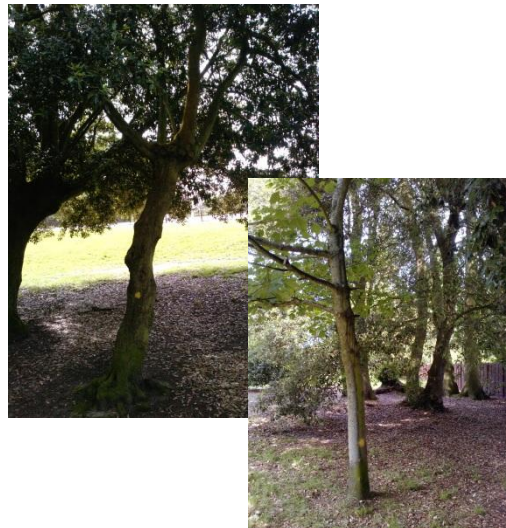
T1288 (holm oak) and T1290 (sycamore)

Both these trees are self-sown and are weak and damaged. Felling them will allow space and light to the surrounding, stronger trees.

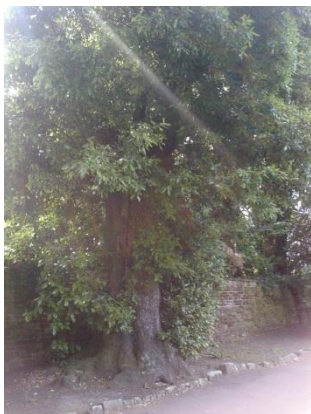
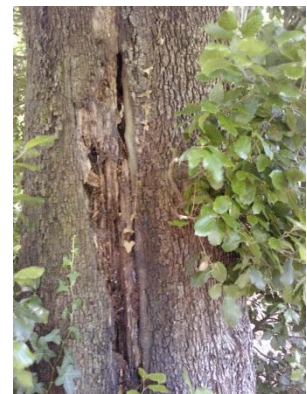
T1388 (holm oak)

This is one of the large holm oaks which stand alongside the church wall. At first glance the tree looks healthy; however, a closer look will show you that it has a very significant area of rot and disease and is slowly dying. Its removal will allow more space in that area for replanting and also more light onto the path.

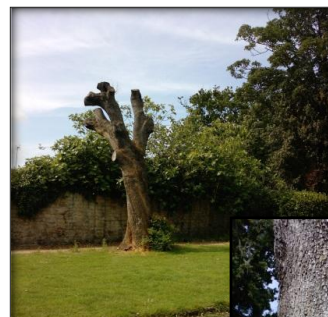
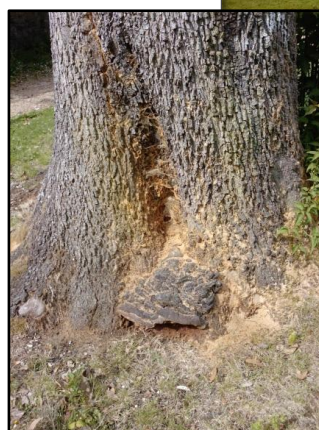
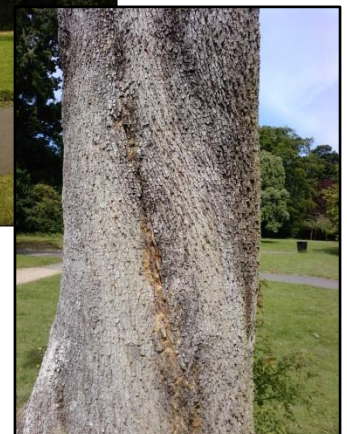
T1405 (holm oak)

This tree stands by the gravel path at the back of Park Court and will be familiar to everyone who walks across the Park and down to the Red Jet. It has serious fungal growth and a significant twisted crack in its trunk; it has effectively been dead for some time and will be felled.

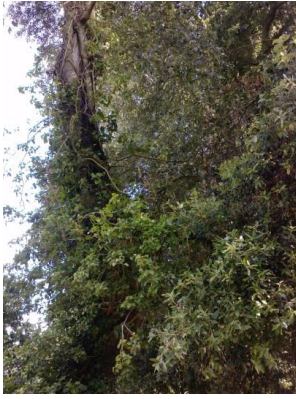
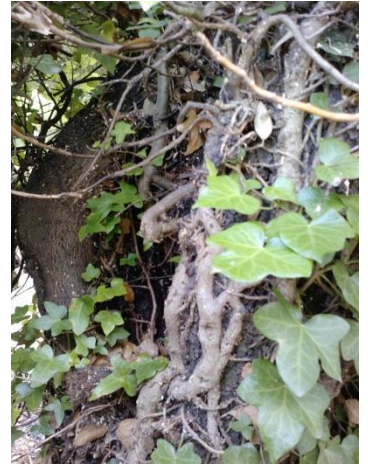
T1420 (holm oak)

This is another tree which at first glance looks healthy; however, a closer look shows areas of rot under the overgrowth of ivy, which will have weakened the tree significantly. It stands close to a path, which makes it a safety risk to the public.

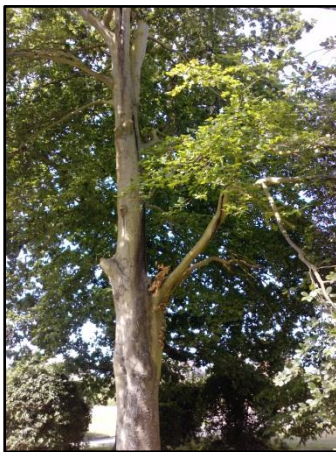
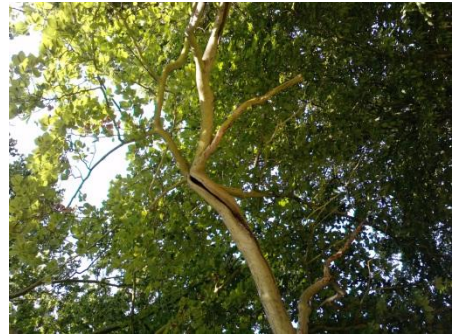
T1422 (beech)

This tree also stands near a path and substantial splits and rotten areas can easily be seen from ground level. The trunk is almost hollow and it is a significant risk to the public.

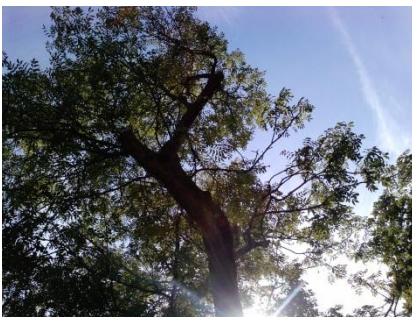
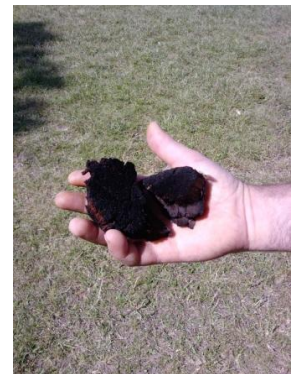
T1453 (ash)

If you look closely at this tree you can see large black funguses growing on the trunk and branches. These are another indicator of decayed wood which may not be visible from the outside but makes the tree unstable. These are pieces of the fungus which have fallen to the ground.
